# AS BUILT PUMP CUTOUTS & SLUICE GATE DETAILS

PROJECT: STORM WATER PUMP REPLACEMENT  
PUMP CUTOUTS & SLUICE GATE DETAILS  
MANDAN, ND

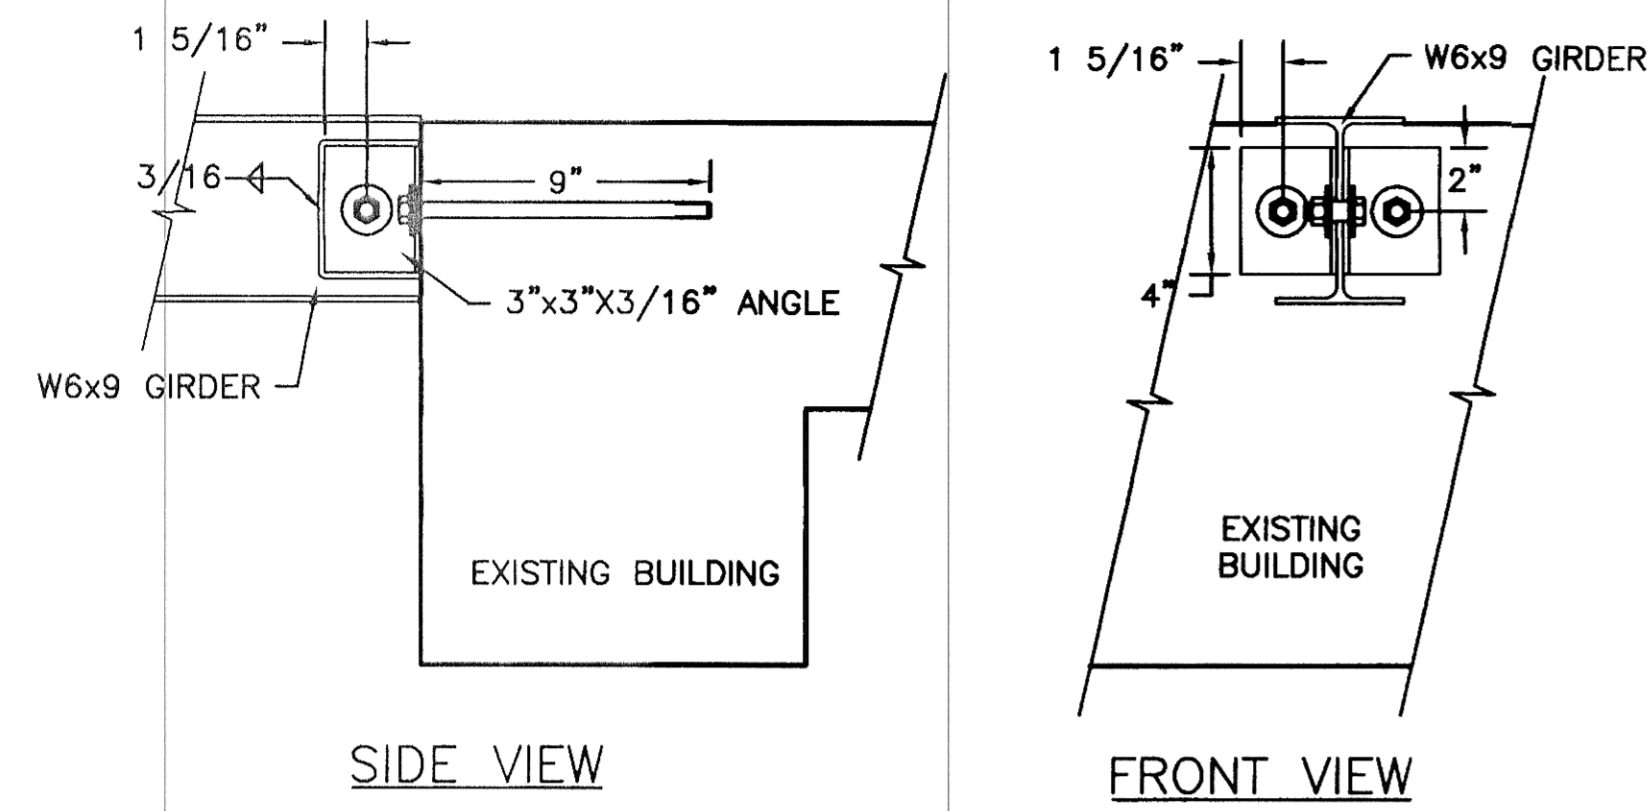
GIRDER TO STRUCTURE CONNECTION

SIDE VIEW

FRONT VIEW

ALL BOLTS A325

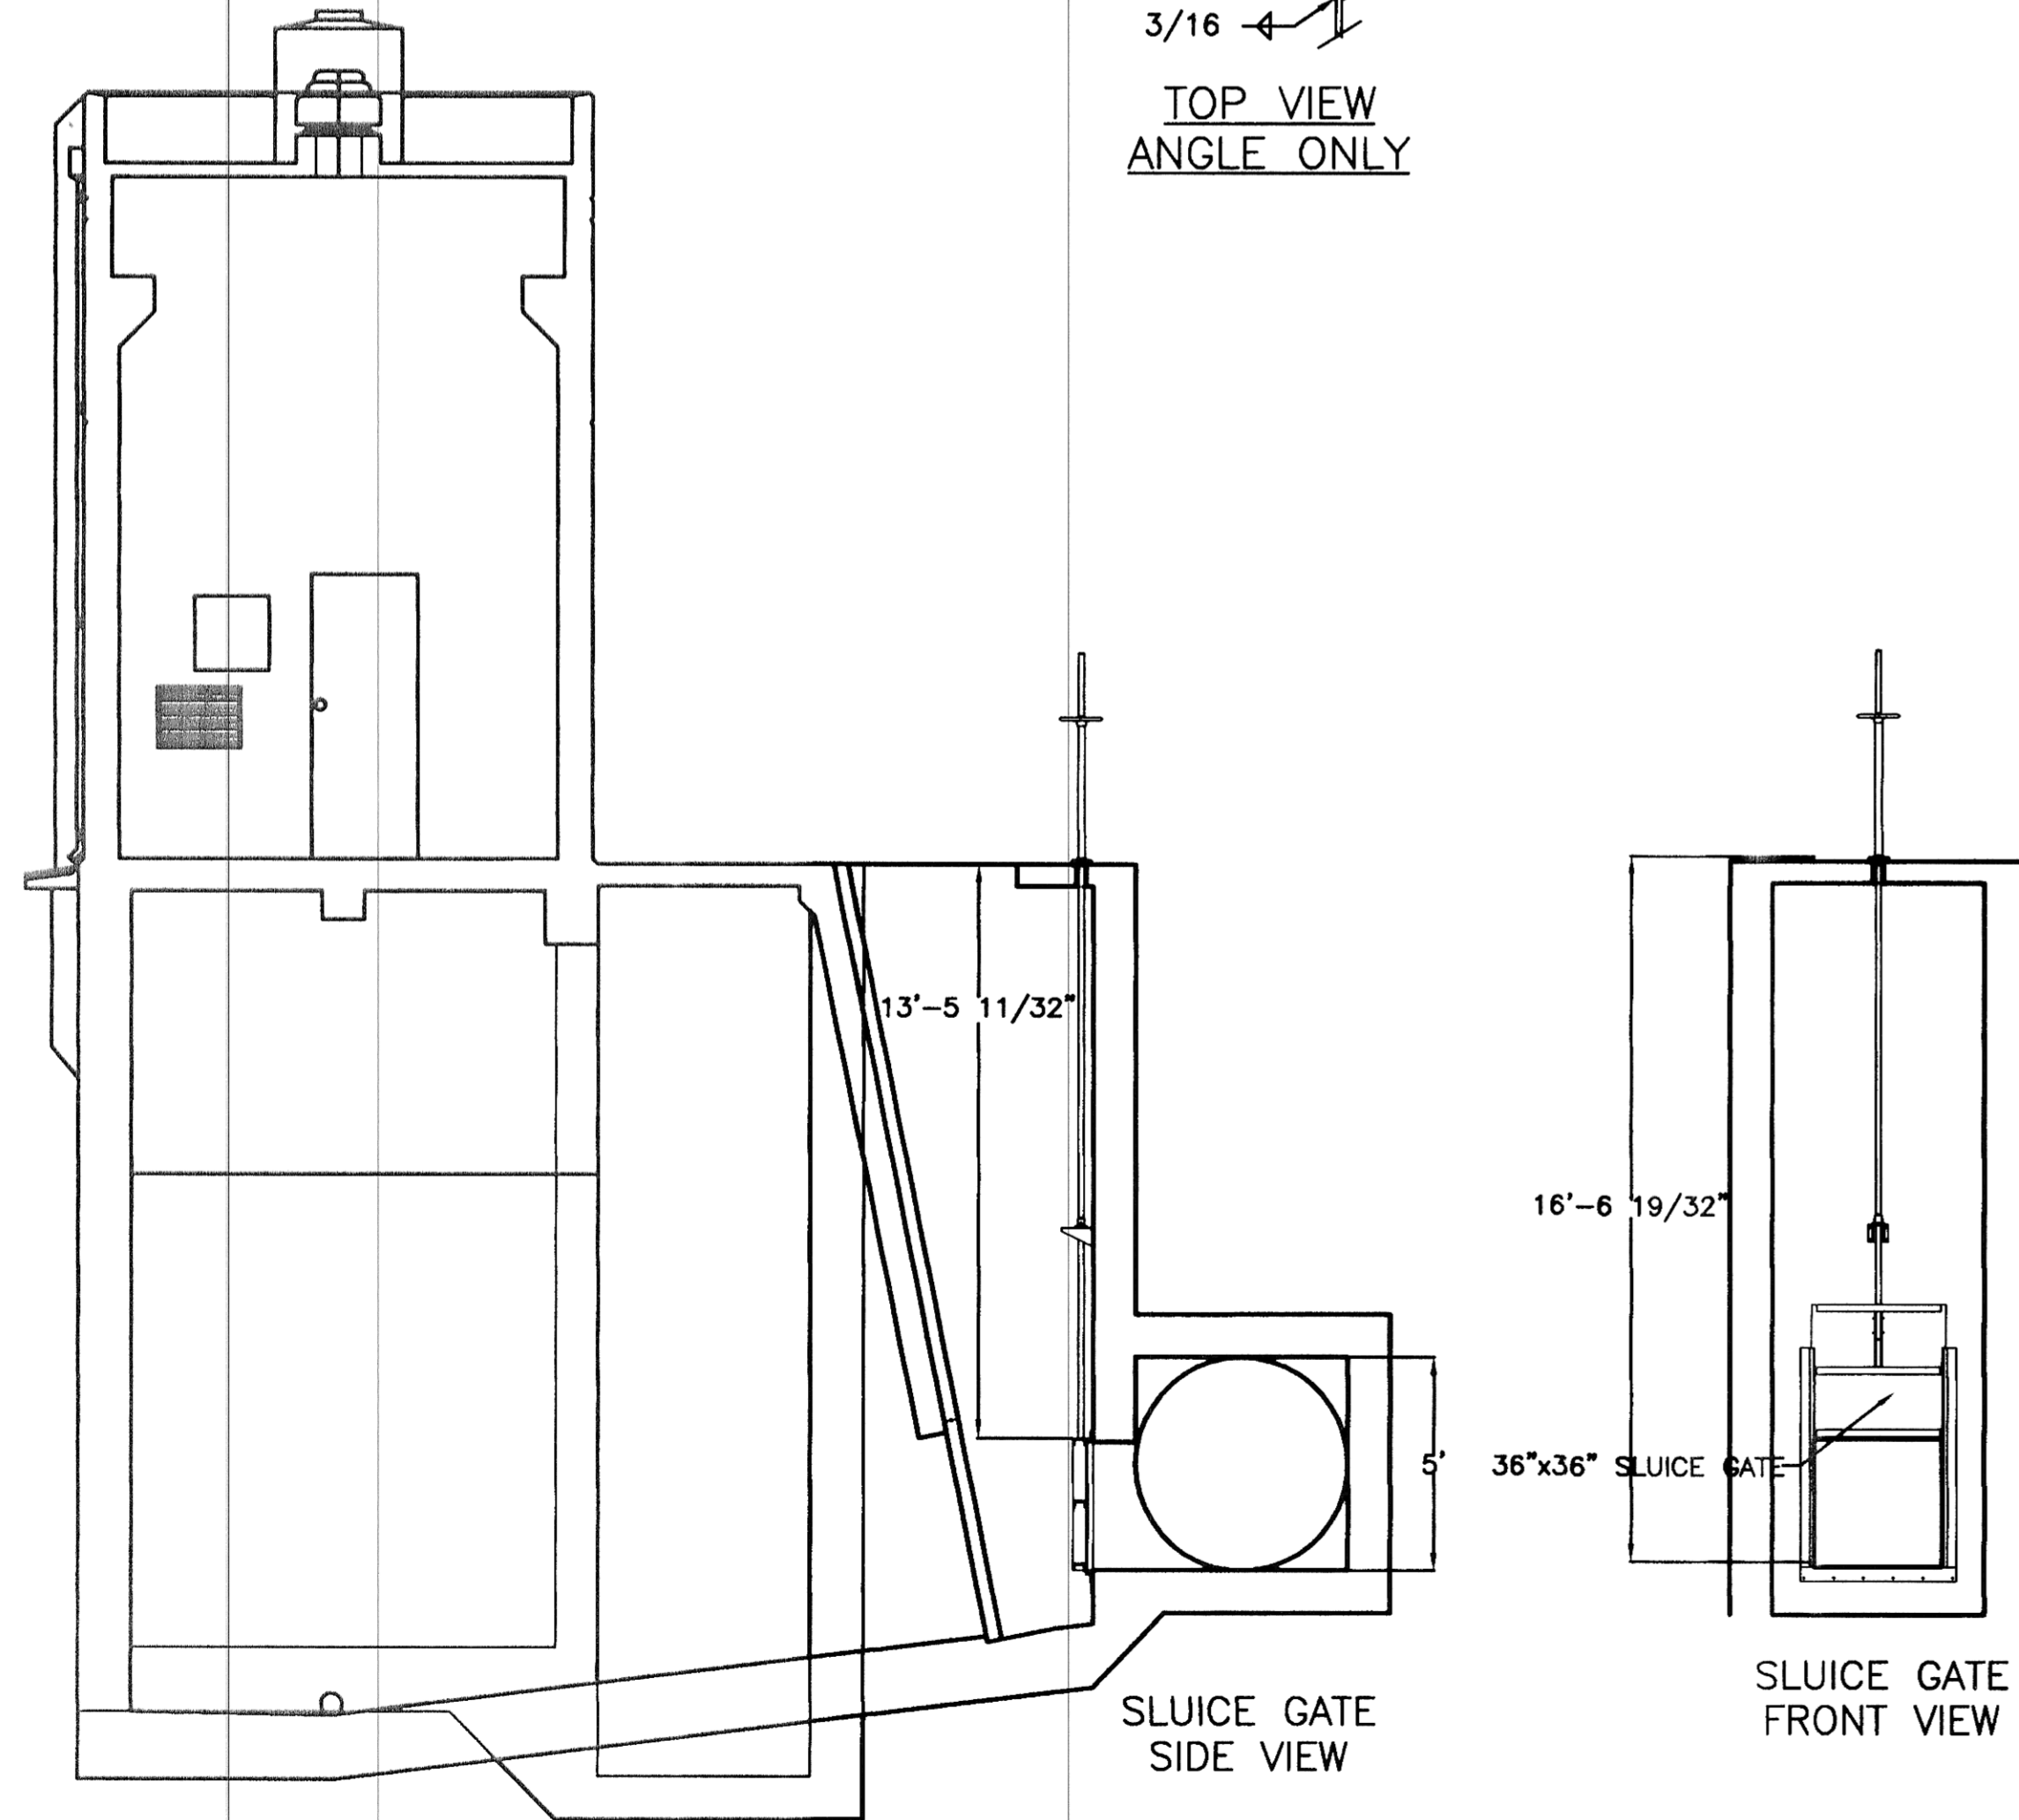
SLUICE GATE OPENING DOOR REPLACEMENT

SLUICE GATE  
SIDE VIEW

SLUICE GATE  
FRONT VIEW

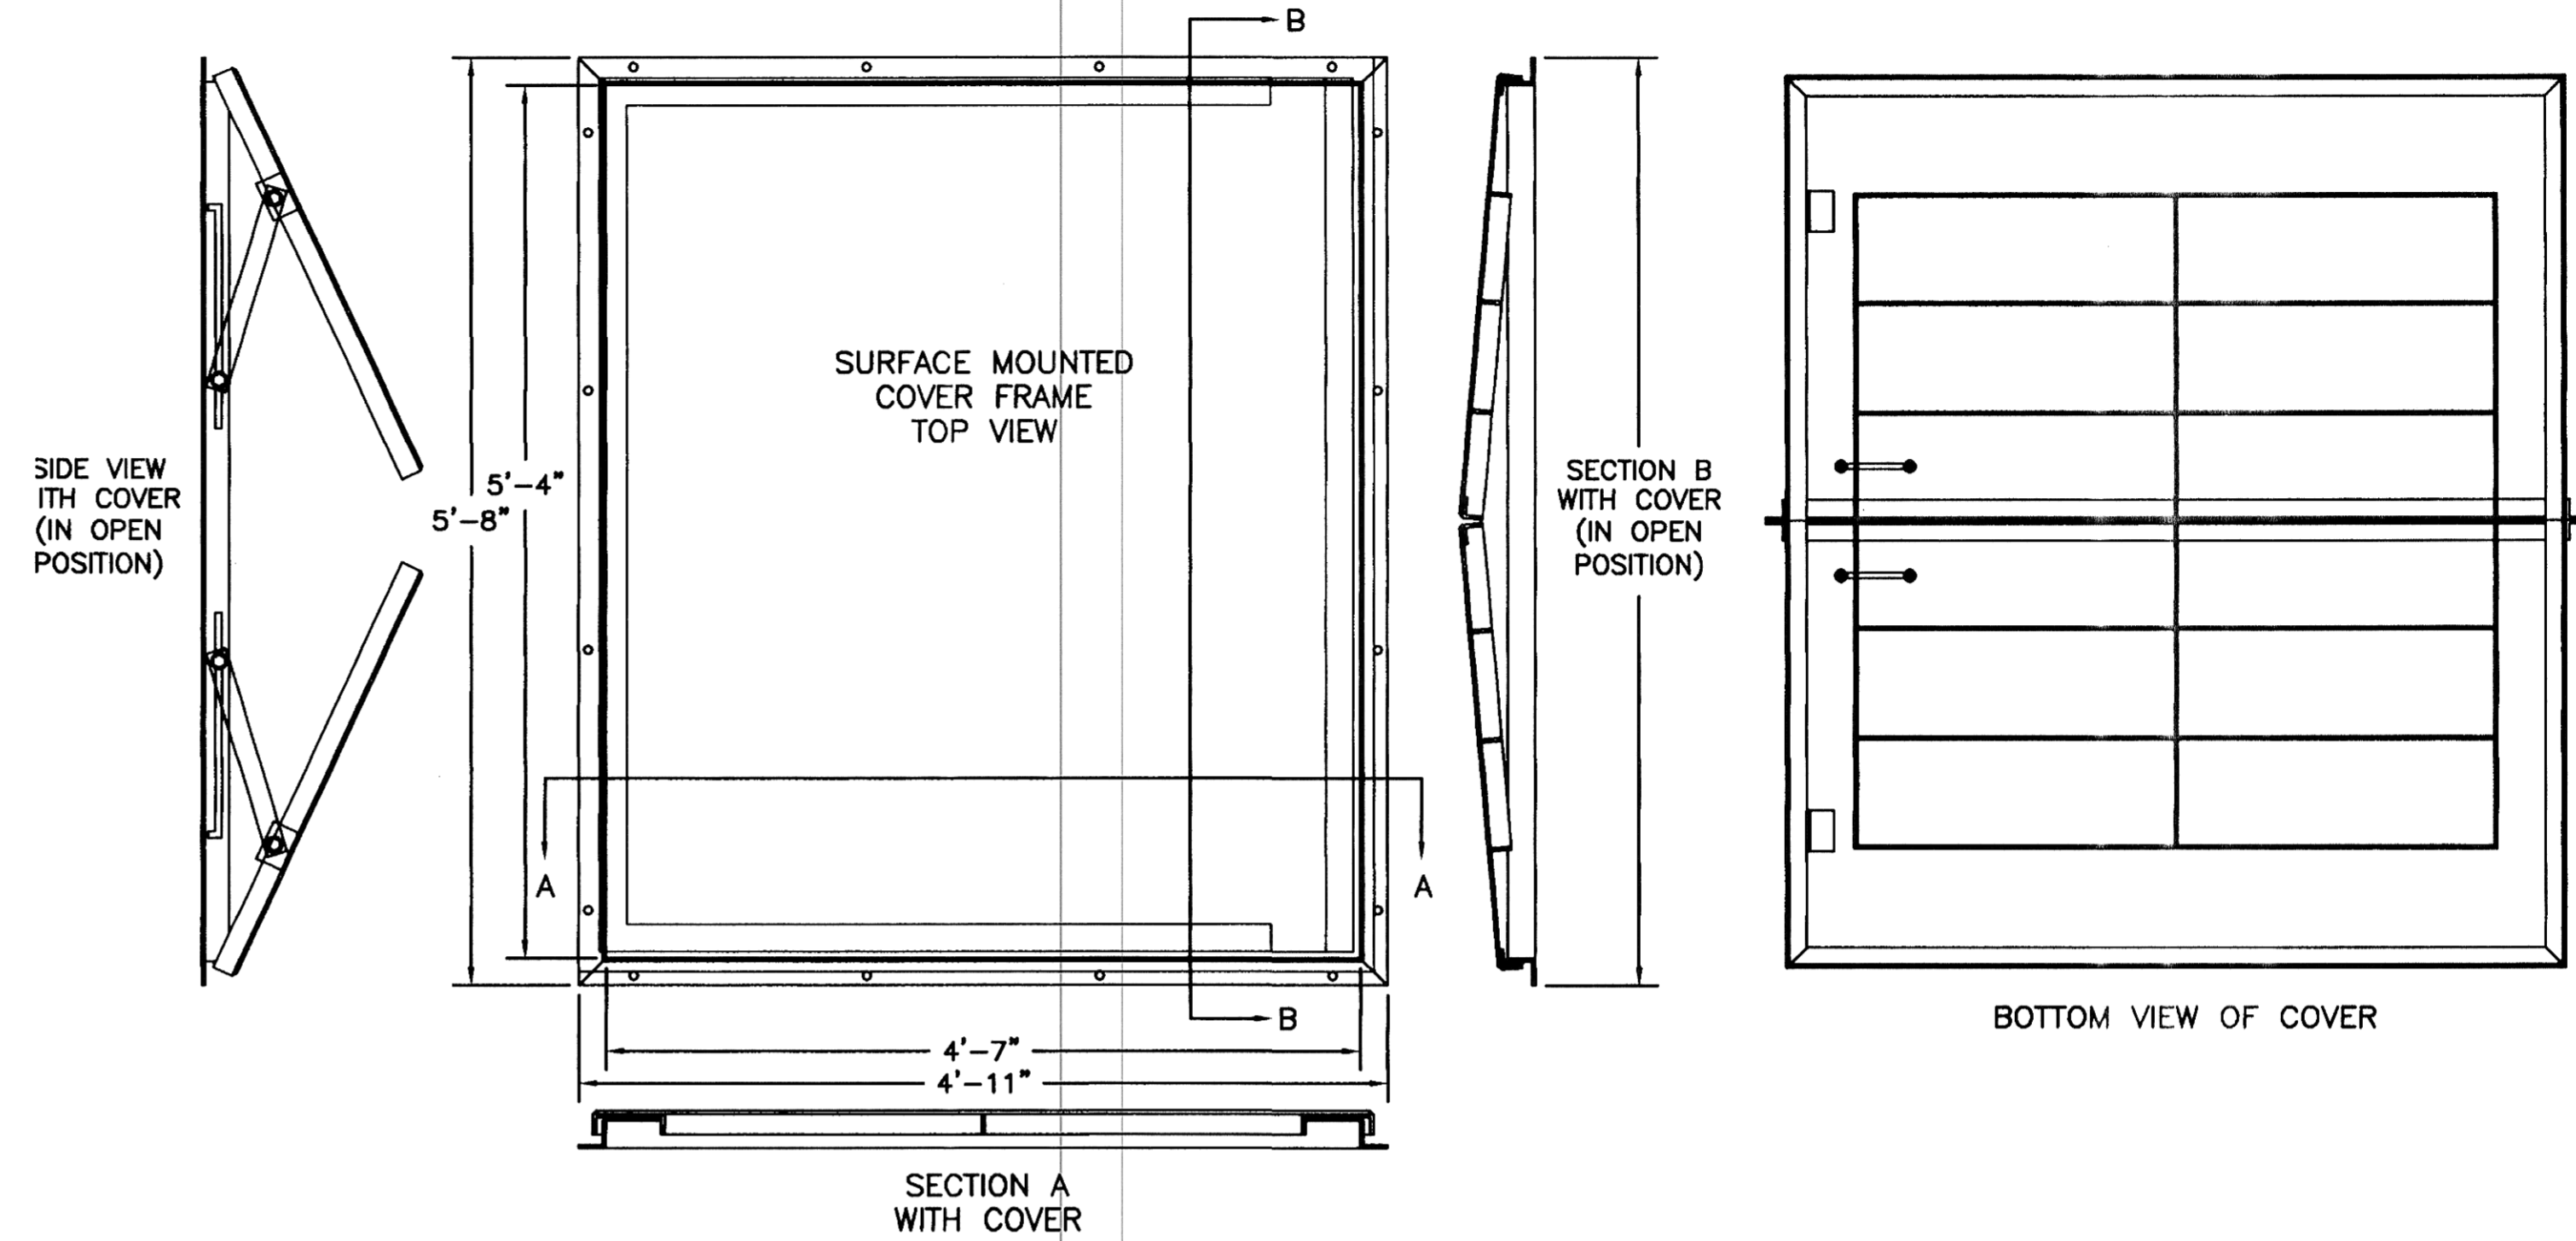
SIDE VIEW  
WITH COVER  
(IN OPEN  
POSITION)

SURFACE MOUNTED  
COVER FRAME  
TOP VIEW

SECTION B  
WITH COVER  
(IN OPEN  
POSITION)

BOTTOM VIEW OF COVER

SECTION A  
WITH COVER

SILICONE BASED SEALANT USED BETWEEN  
THE BOTTOM OF THE FRAME AND  
THE EXISTING STRUCTURE
